## **Microvia Reliability**

### **Concerns in the Lead Free Assembly Environment**

**Joint Paper By**

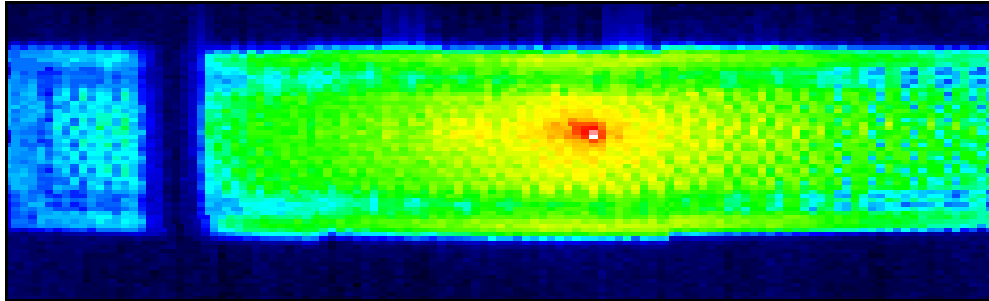
**Thermograph of a Failing Via  
Photo 2**

thermographic camera allows direct visualization of the exact location of the hottest microvia. The worst case failing microvia is seen as a high temperature hot spot on the surface of the coupon. This is a powerful tool for finding failure locations for subsequent microsection analysis.

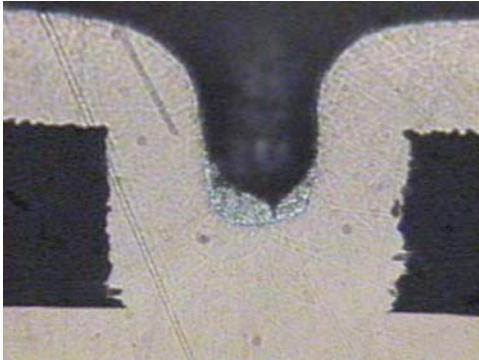
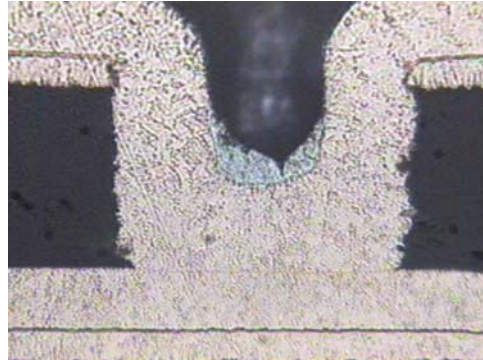
### An Un-Etched and Etched Microvia

In photos 1 and 2 a good microvia was photographed before and after etching to demonstrate the degree of detail that may be achieved. In photo 2 the layer one foil, electroless copper, interface between the bottom of the microvia and the target pad and the plating on the top of the target pad are easily visualizes after a microetch. In photo 1 all internal detail is not visible. It was demonstrated that a well-controlled micro etch, using hydrogen peroxide and ammonium hydroxide, greatly enhanced the physical details of the failing interconnect and improved the ability to objectively evaluate failures and causative mechanisms. The microvias evaluated in this study had a mild microetch.

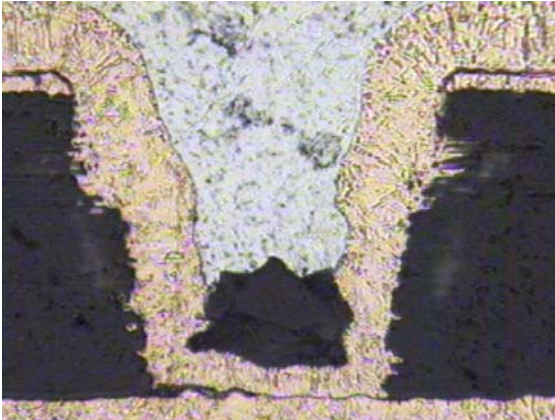
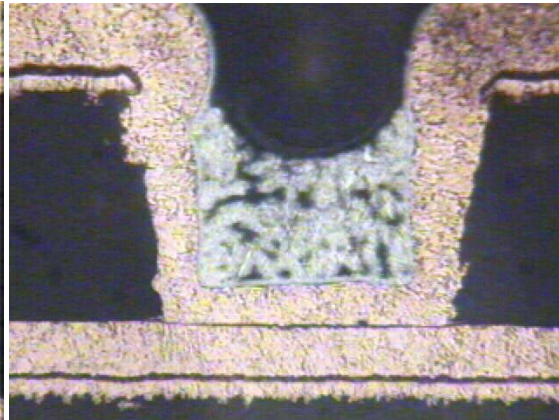
### Microvias Contributing a 10% Increase in Resistance

IST equipment has the inherent ability to stop testing an individual coupon automatically when it achieves a 10% increase in resistance, in any test circuit. This assures that the failing circuit is stopped before the coupon has achieved a catastrophic failure. Photo 3 is of an obviously failing microvia, while photo 4 has a more subtle failure mode. Both coupons were stopped at a 10% increase in resistance and then identified, with thermal imaging techniques, as the microvias contributing the highest resistance to the failing circuit.

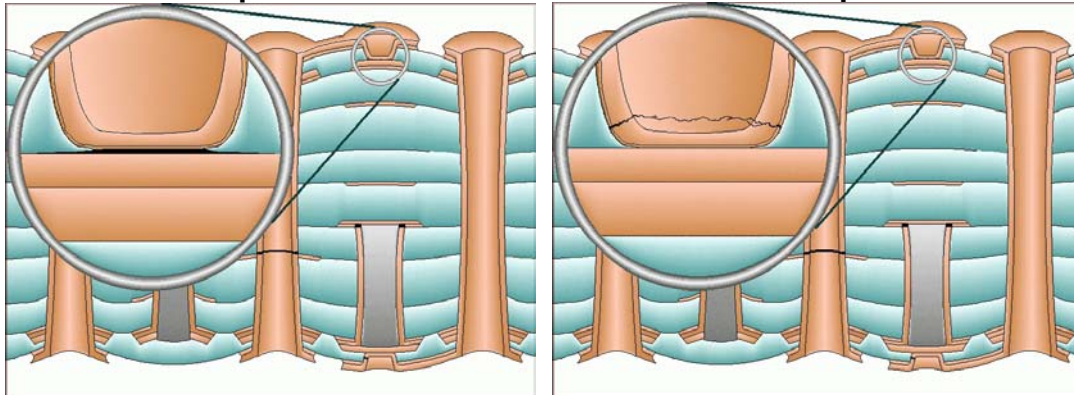
### Two Microvia Failure Modes – Pad Separation and Barrel Cracks

Armed with these tools a comprehensive failure analysis can be achieved. Failure analysis suggested that there were two distinct failure mechanisms at work in these coupons. Barrel cracks were found at the base of the hole wall of a few microvias. Much more common was debris under or above the electroless copper deposit, at the interface with the target pad leading to pad separations. The analysis suggested that the dominant underlying contributor to the microvia

failures in this study was an inherent weakness at the interconnection between the base of the microvia and the target pad. The electroless and electrolytic copper thinned from the knee to the bottom of the microvia and was believed to be a contributing factor to the barrel cracks.

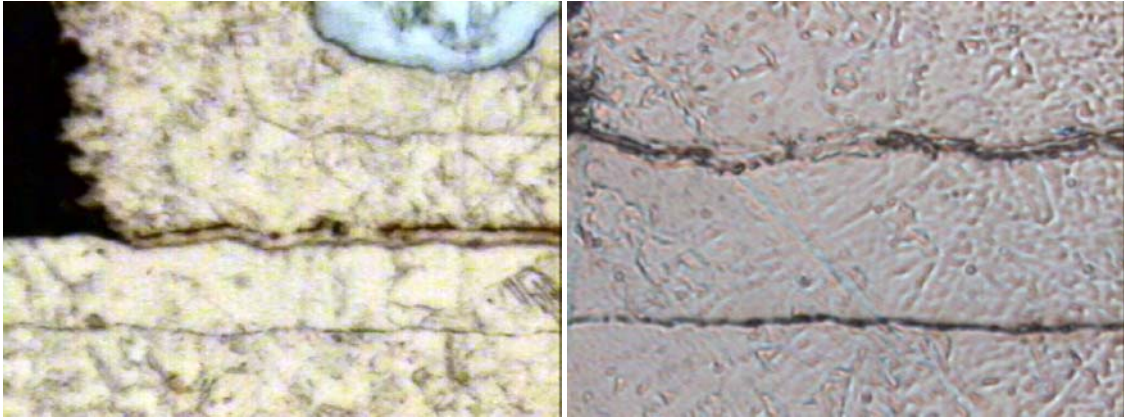
**Precursor “Black Dots” and Coalescing Micro-cracks**  
**Photo 5** **Photo 6**

Frequently failing microvias exhibited precursor black dots at the target pad/via plating boundary. The black dots enlarge into small cracks that then coalesce into large cracks. This process is like a tearing along perforations in a piece of paper. Commonly the cracks would appear in the center and at the perimeter at the base of the microvia. Microvias that were advanced in the failing process had the appearance of a crack that started on one side of the base of the microvia and progressed completely across the interface.

Photos 5 and 6 exhibit the precursor black dot above and below the electroless copper. Photo 7 shows coalescing micro-cracks both above and below the electroless copper.

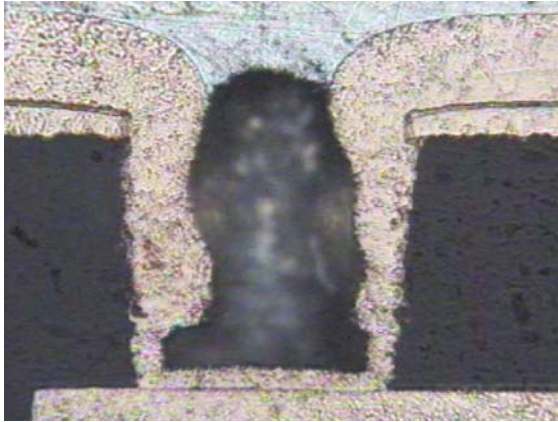
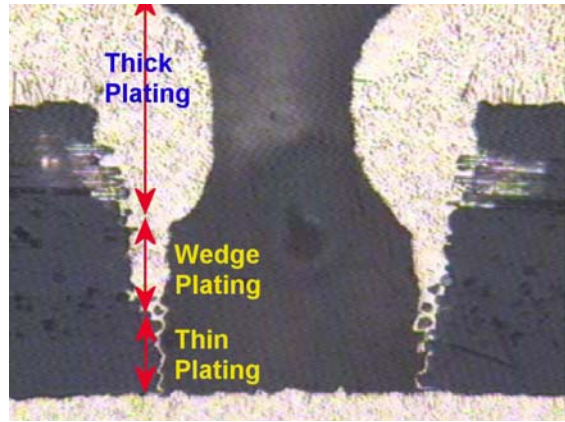
**Thinning of Electrolytic & Electroless Copper Below the Knee of the Hole**

Another observation is that the electroless and electrolytic copper quickly thins below the knee of the microvia. Electroless that measured 120 millionth of an inch on the surface of the pad can be un-measurable at the base of the microvia. The thickness of the electroless and electrolytic coppers was reduced, in some cases dramatically, as the deposit descends into the microvia. The effect of thinning electroless can produce a condition commonly called step plating. Photo 8 demonstrates the reduction in electroless, which is plainly visible on top of the surface foil and only barely discernible at the base of the microvia. Photo 9 is an extreme example of wedge plating on a microvia processed with direct metalization. Usually microvia barrel cracks are associated with process conditions that are rejectable to IPC 6012 or other applicable documents. If these conditions were to be discovered using random microsections the lot would have been rejected. The problem with thinning copper plating is that this condition is random and may occur any where on the board. Not all microvias would have the exact same condition. With failure location method it is very successful in finding this condition when it is random in nature.

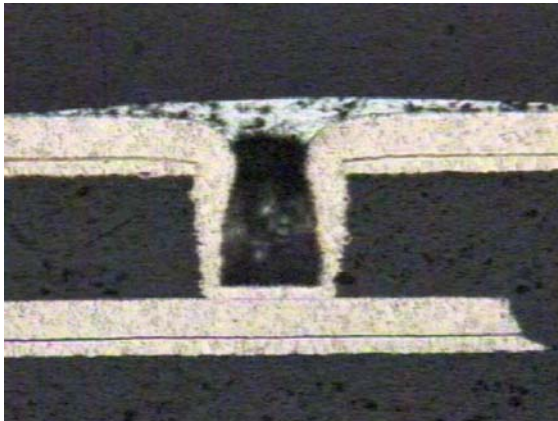
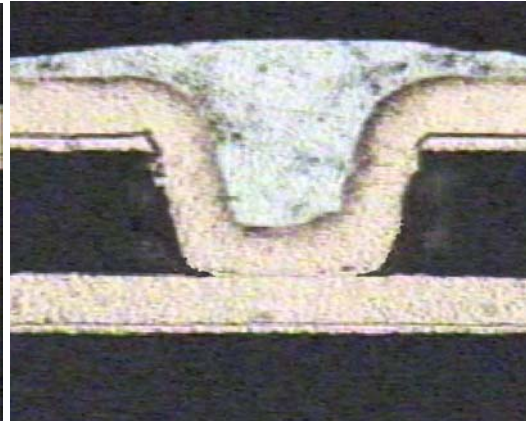
### **Cylindrical Microvia vs. Dish Shaped Microvia**

It was found that the shape of the microvia was also contributing to the robustness of a microvias. Bowl shaped microvias appeared to have a more uniform copper distribution to the base, as compared to microvias are cylinder shaped. Bowl shaped microvia were found to achieve higher cycles to failure than cylindrical microvias.

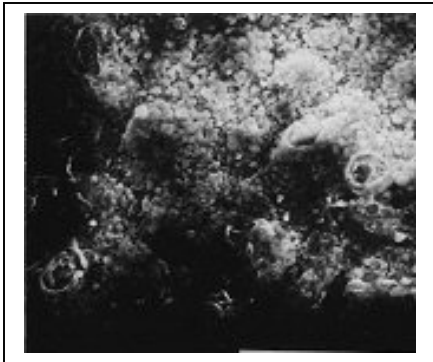
**Photo 12**

Photo 12: Target pad after laser drilling – Debris is visible

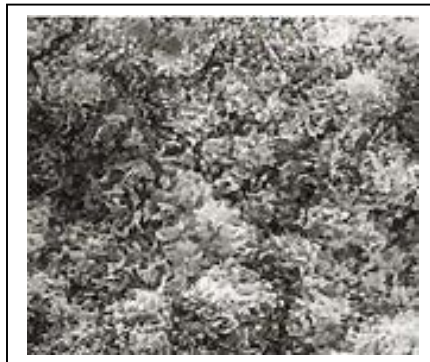
**Photo 13**

Photo 13: Target plasma desmear and microetch – Some debris remains

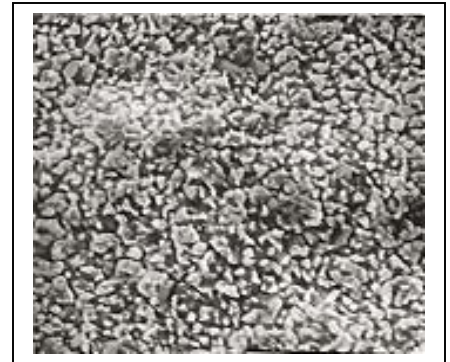
**Photo 14**

Photo 14: Target pad after  $\text{KMNO}_4$  desmear and microetch (no plasma) – Clean
